SafeLine LYRA Case Study

Key insights and takeaways 2018-2023

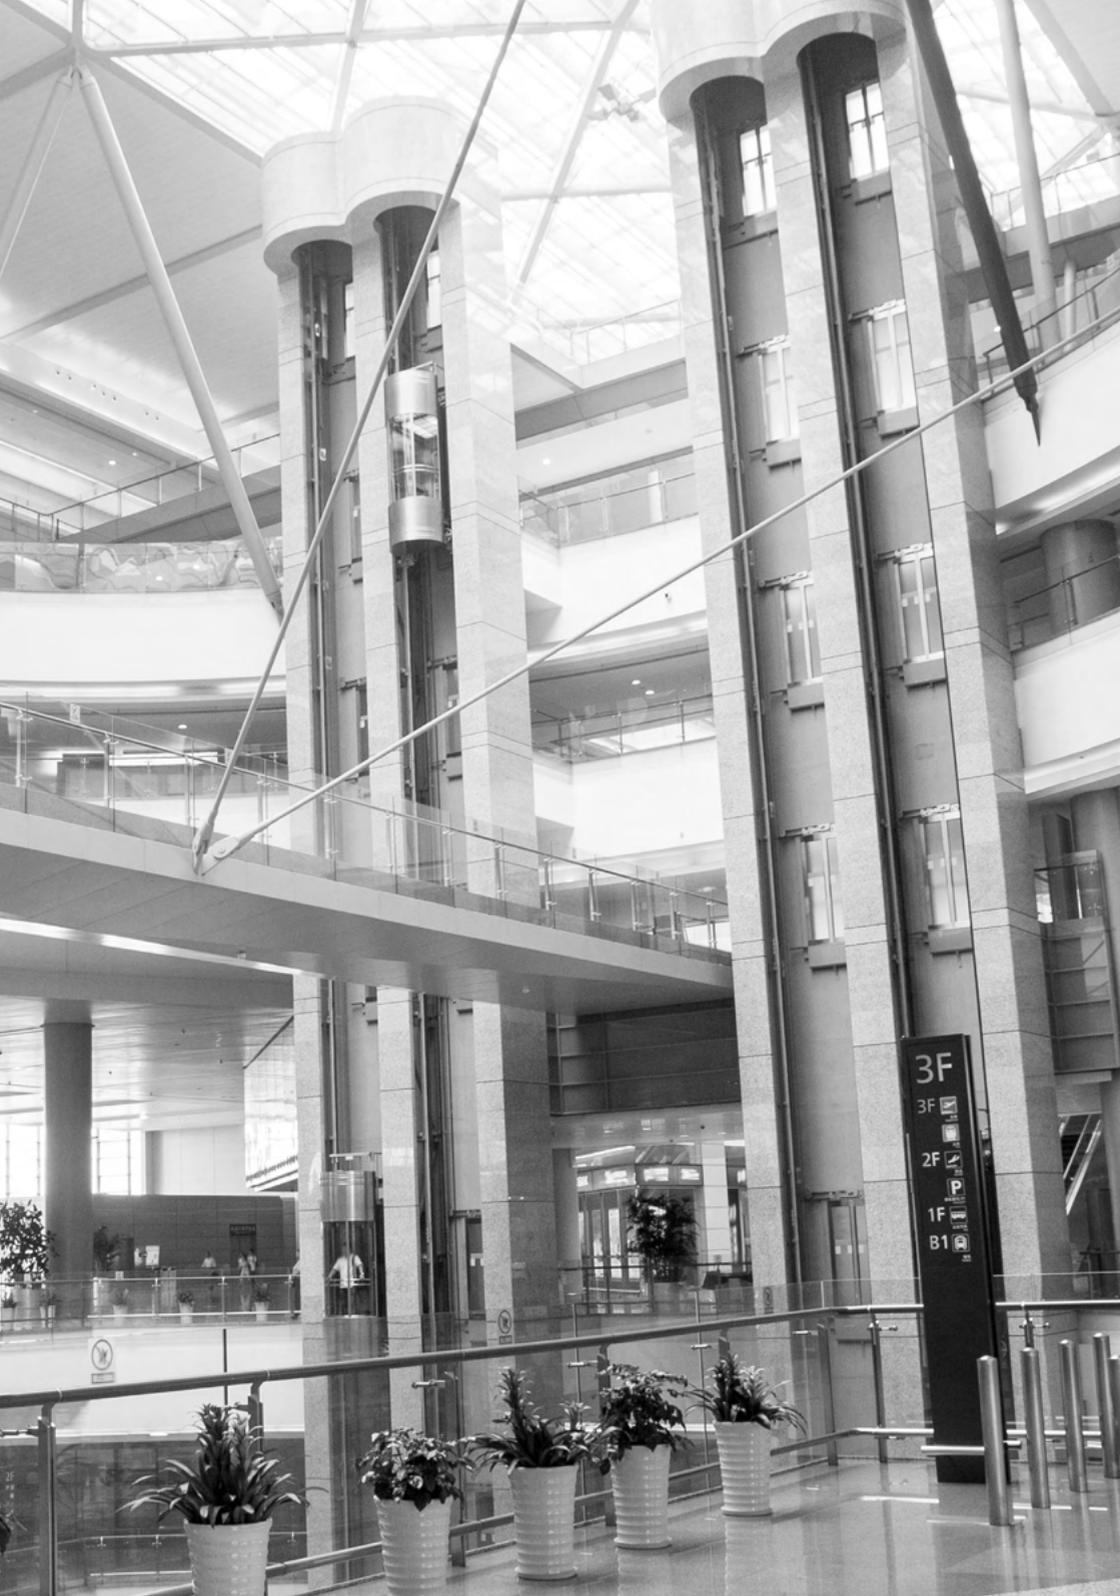
How it works

1. LYRA is installed on car roof by a lift engineer in less than 1 hour.
2. An account is created in ORION for the lift.
3. LYRA feeds unique data into ORION.
4. Lift engineers use this data to make a diagnosis and increase the uptime of your lifts.

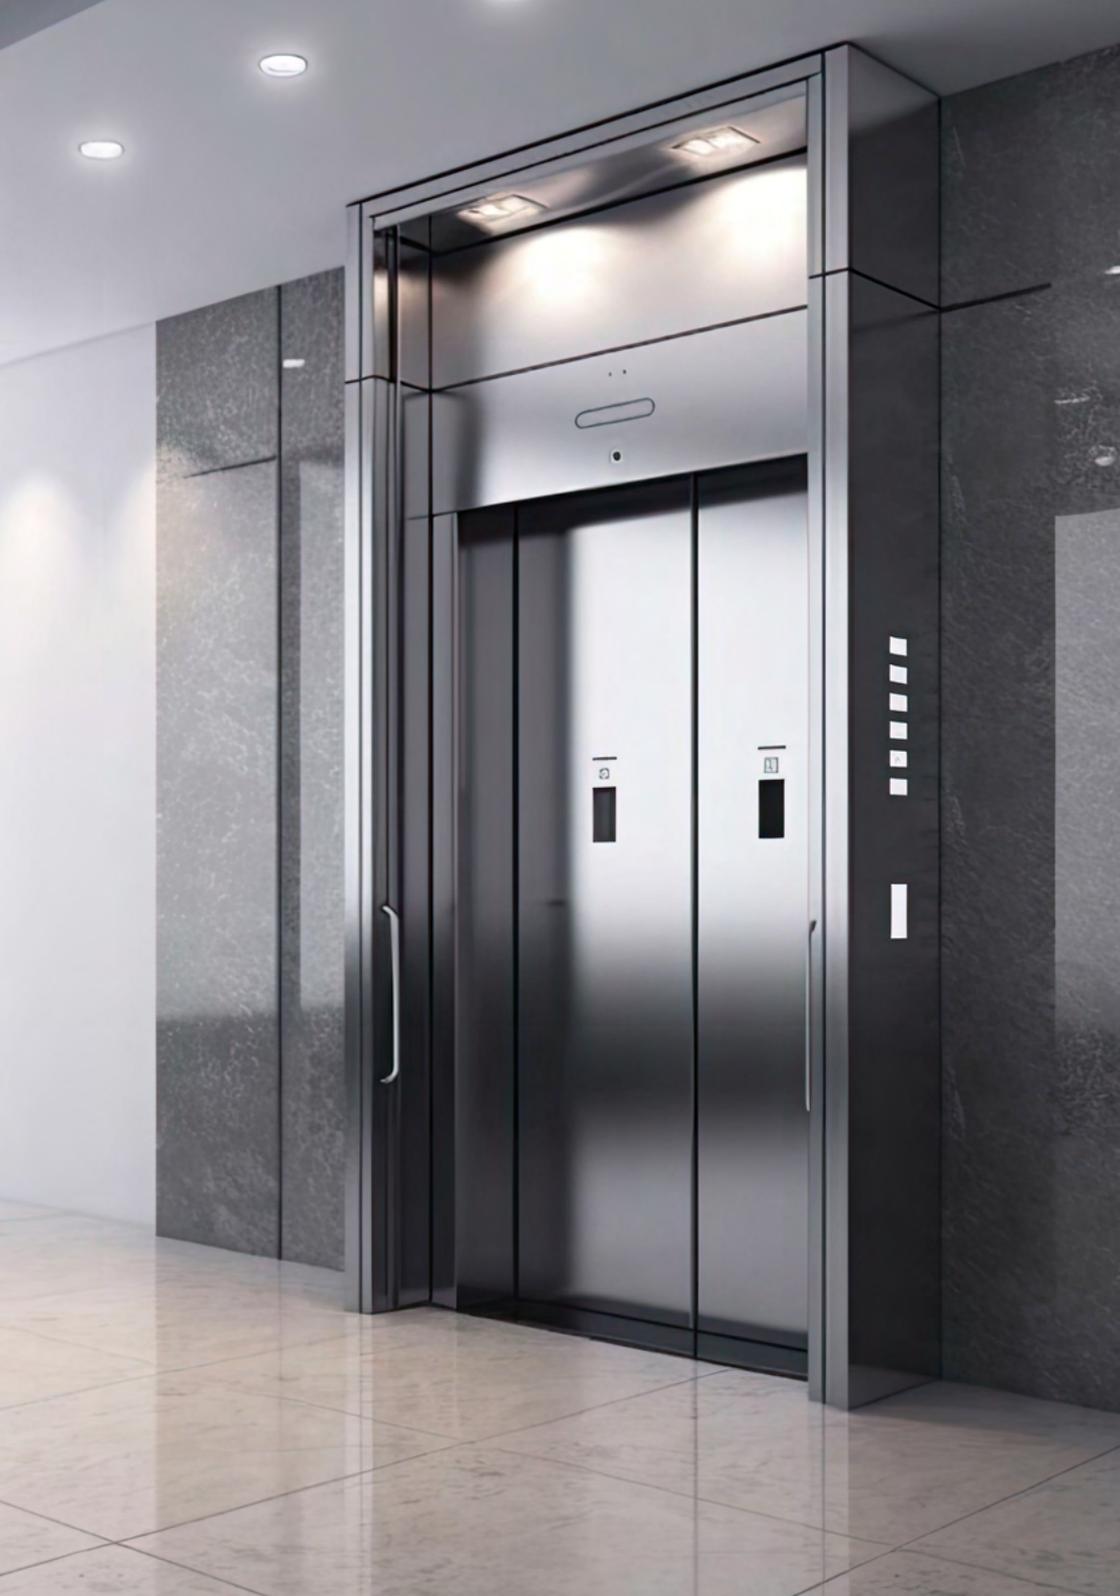
SafeLine LYRA is a groundbreaking hardware solution that converts traditional lifts into intelligent, proactive systems. This compact and lightweight device can be easily applied to any lift, providing seamless integration without requiring a direct connection to the lift control system. LYRA operates as a fully independent solution, relying on a 4G connection for wireless data transmission.

Main device

Power supply:	5 VDC USB mini B
Current consumption:	Average 350 mA, Peak 650 mA
Size (HxWxD):	118 x 118 x 23 mm
Weight:	210g
Interfaces:	4G LTE, BLE
LTE Bands:	B1 (2100), B3 (1800), B7 (2600), B8 (900)
Antenna:	Integrated (external antenna optional)
IP Code:	IP20
Operating temperature:	-10°C – +60°C
Air Humidity:	30% - 90% RH
Min. speed:	0,4 m/s
Built-in sensors:	Accelerometer, magnetometer, thermometer
External sensors:	Max 4 door sensors (USB-A)
Installation time:	>20 min

Door sensor

Size (HxWxD):	118 x 118 x 23 mm
Weight:	210g
Cable length:	2000 mm
Connector:	USB Type A male plug
Jacket material:	PVC
Operating temperature:	+5 C° – +40 C°
Air humidity:	30% – 90% RH
IP Code:	IP65
Built-in sensors:	Accelerometer, magnetometer

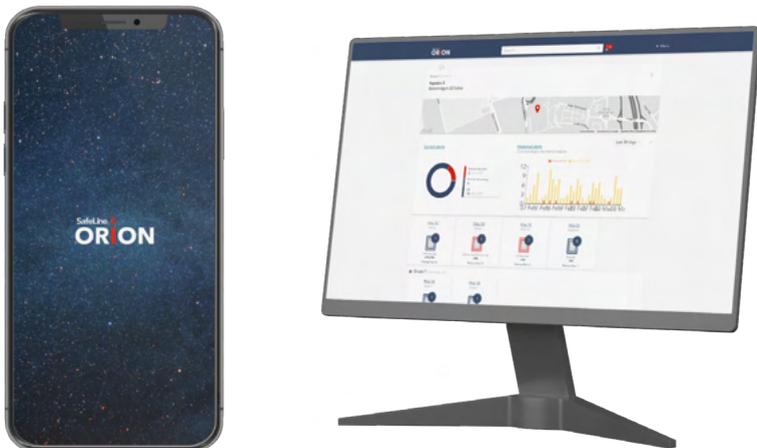
SafeLine **ORION**

The intuitive ORION interface provides you with a unique day-to-day overview of all your connected lifts' condition - serving as key to proactive maintenance of your lifts and providing you with unique lift statistics and data. With ORION, it's easy to analyse the usage of your lifts and all its connected SafeLine equipment - always staying on top of what is happening with your lifts right now.

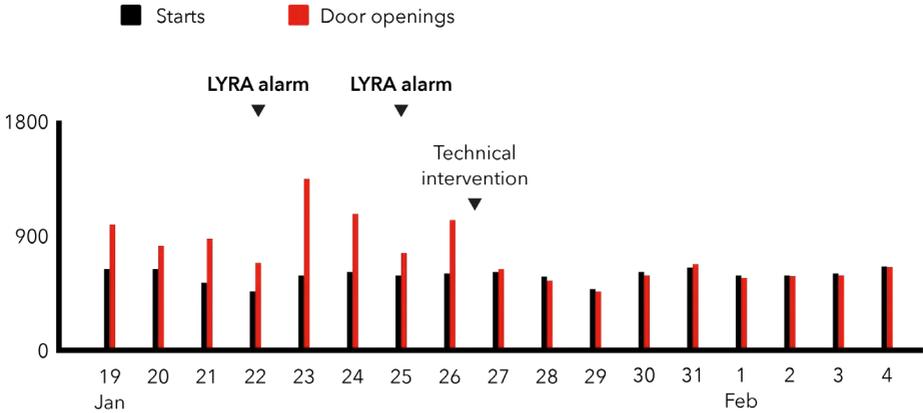
Excessive amount of door openings detected by LYRA

An excessive amount of door openings compared to the number of travels, indicating a fault with the lift doors on floor 1 and 6.

After being warned in SafeLine ORION, a lift engineer was dispatched on-site and discovered an intermittent fault with the landing door contact. By measuring and comparing the last 200 travels and the last 20 travels to the floors, we can clearly see an increase highlighted in the graph. Once the repair was complete, we could see immediately that the door openings returned to a normal state compared to travels.

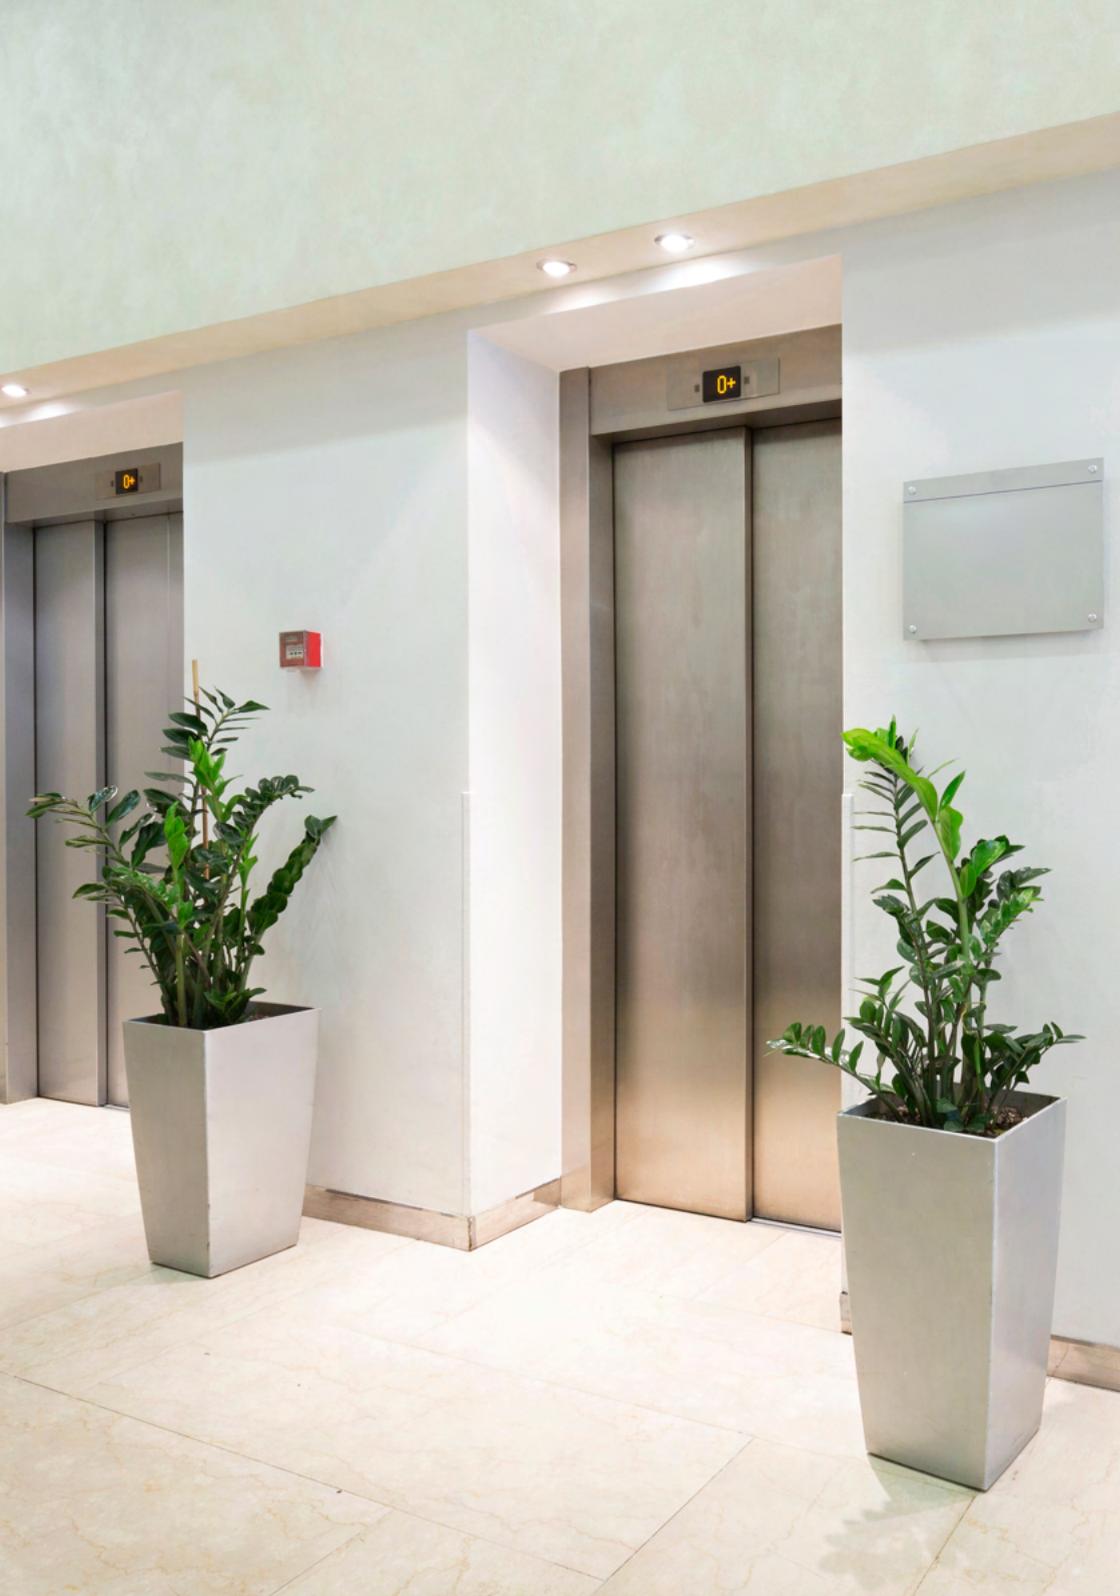
Upon further investigation it was discovered the lift had been left in permanent test run mode since its installation three years ago, causing excessive wear on parts and reducing the lift's lifespan by almost 50%, leading to frequent breakdowns.

After solving the issue, the number of travels significantly decreased, highlighting the importance of LYRA in detecting such faults and preventing further damage to lifts.

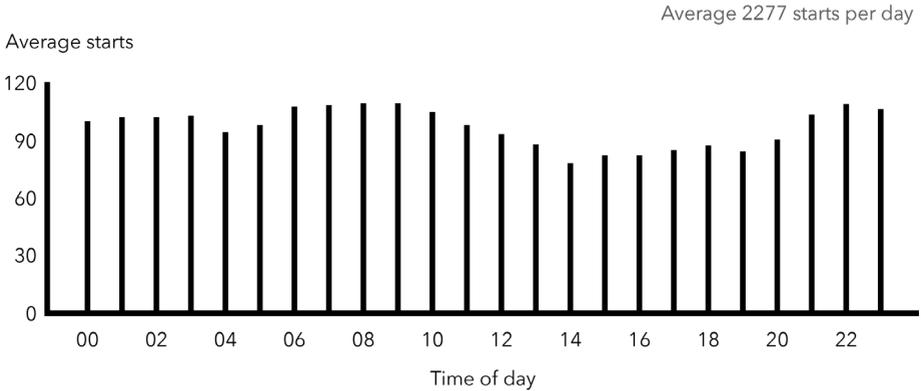
Excessive amount of starts detected by LYRA

LYRA detected that a lift was making an excessive amount of starts each day, almost 100 per hour, no matter the time of day.

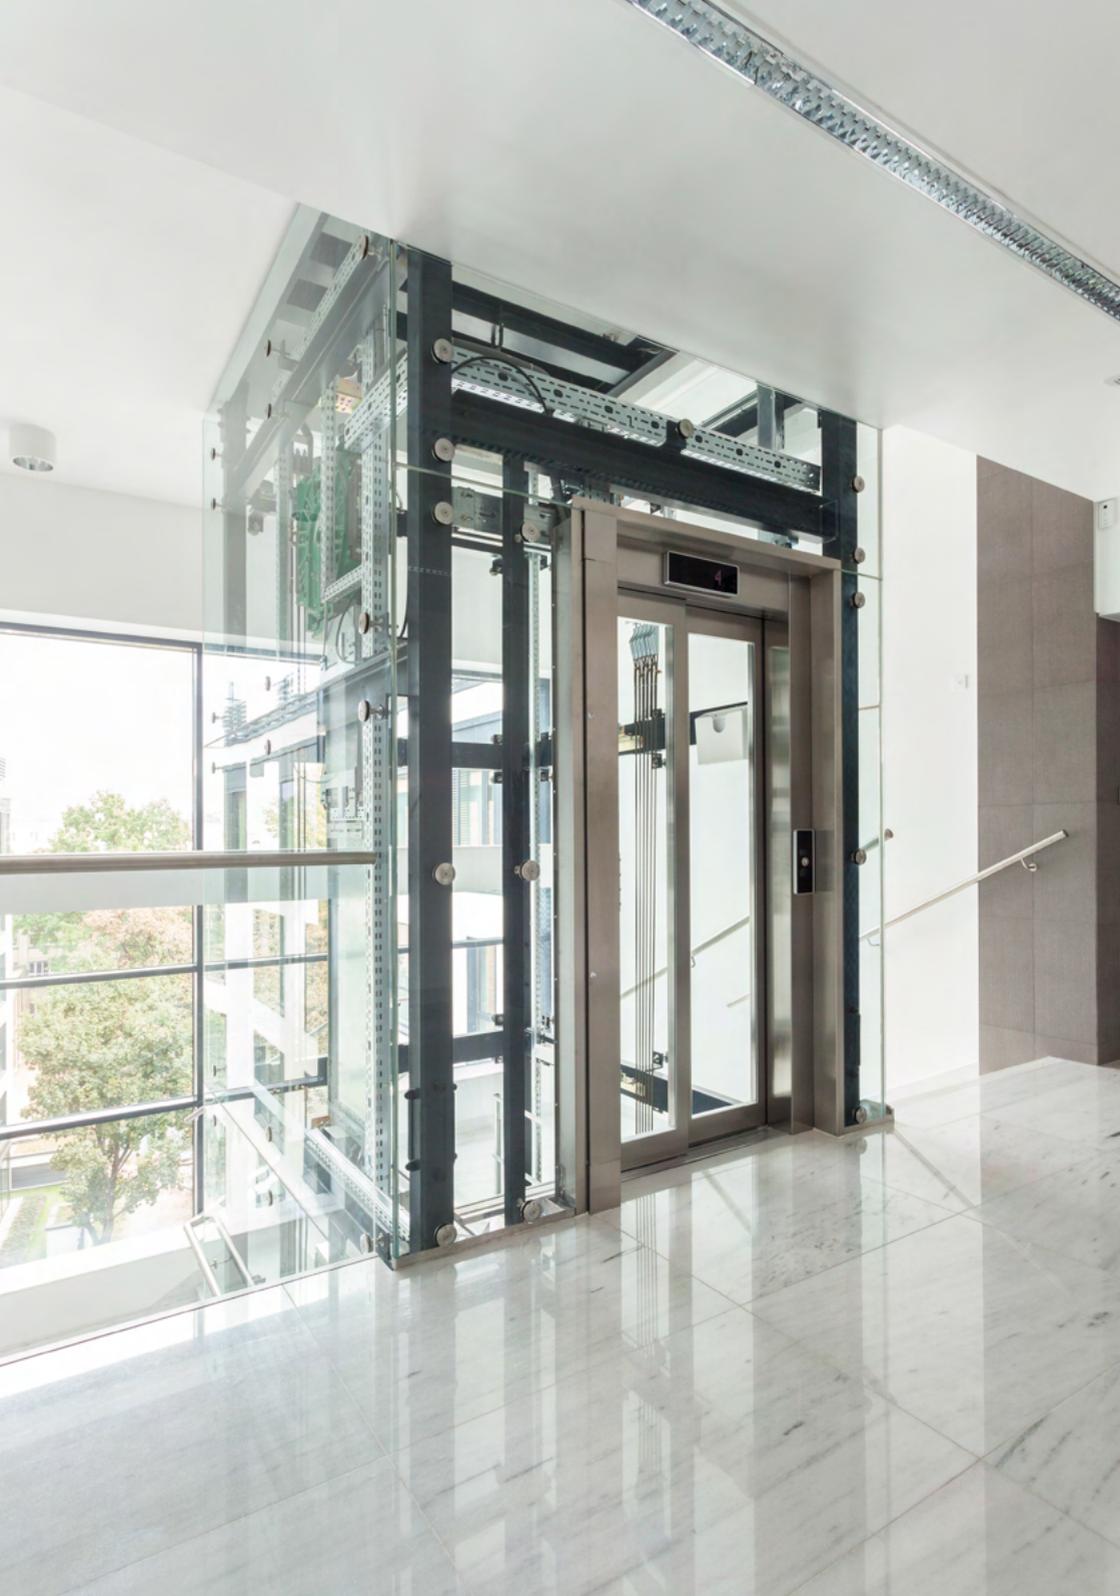
Standstill detected by LYRA

Location: **Car group in office building, London**

LYRA warned about this problem 28 hours before the controller did. If it had been attended to, the matter would have been resolved on a weekday instead of the weekend, reducing the price of emergency maintenance in half.

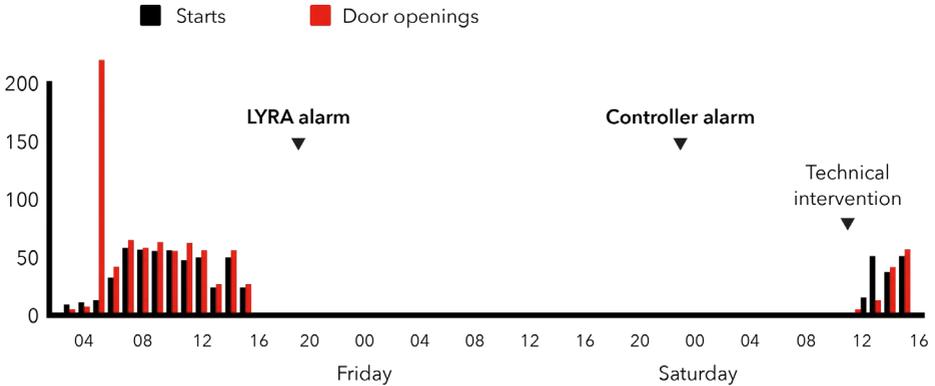
LYRA detected an abnormality in the number of travels on a Thursday and alerted the customer about this. Unfortunately, this was not communicated to the technician. On Friday at 23:00, the controller reported the fault.

Upon investigation, this turned out to be a simple lock fault. Once the fault was investigated, it had become a Saturday, meaning an increased cost of service, compared to if the issue had been handled on a weekday.

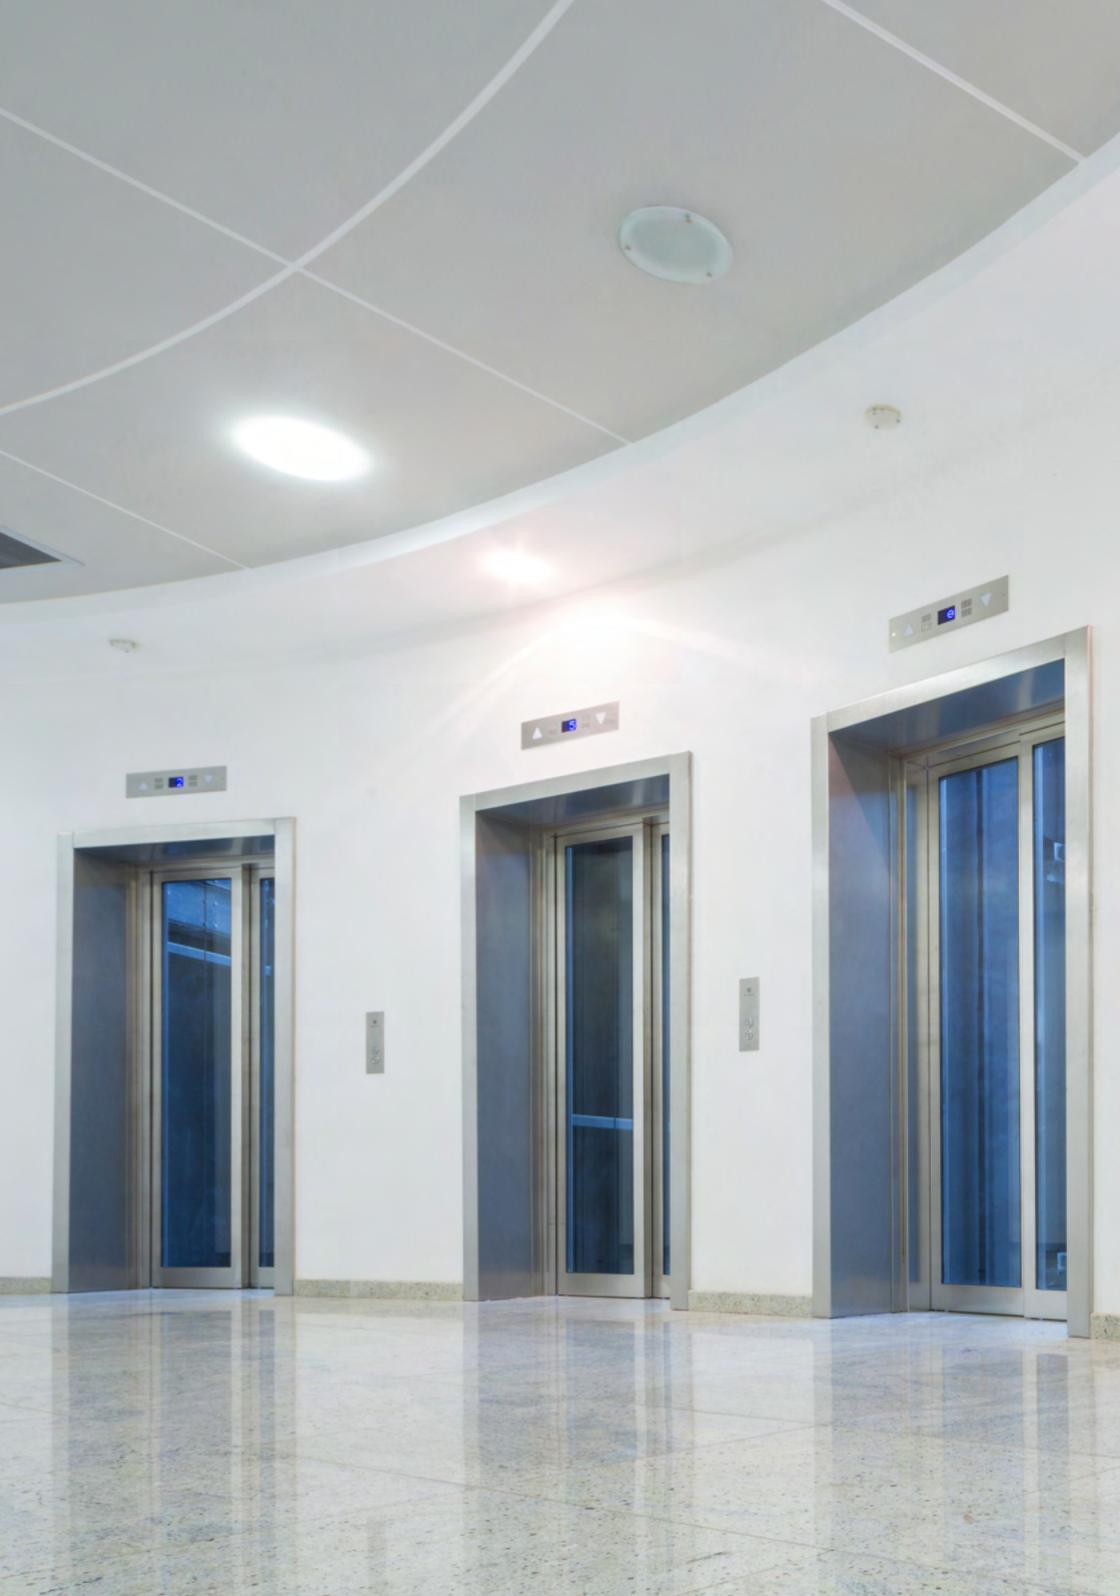
Built-in error in car group detected by LYRA

Location: **Car group in office building, Stockholm**

Upon investigation, it turns out the car group had a built-in error in the controller, causing the out of proportion amount of travels for one of the lifts and a much higher wear and tear.

Even worse, being part of a car group, this problem wasn't isolated to the singular problematic lift. The remaining under-used two lifts needed the be prematurely exchanged because of the significant wear and tear to the one.

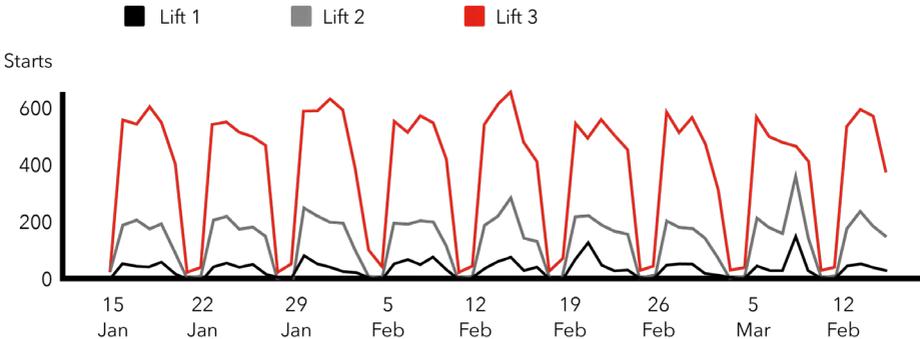
LYRA detected a lift in a car group were taking five times as many travels as the other lifts in the same group.
